Cloverleaf Lakes, Shawano County
Shoreline Assessment 2020

2020 Cloverleaf Lakes Survey

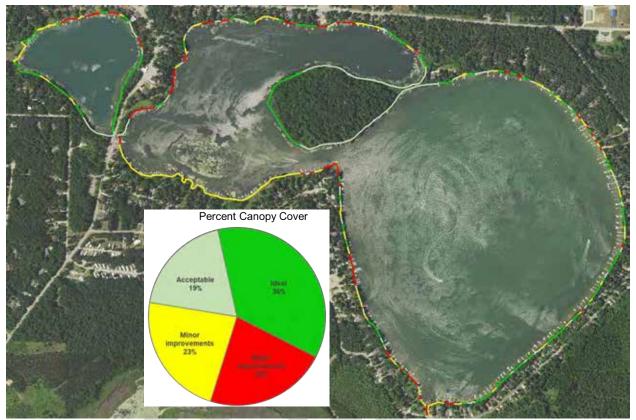
The Cloverleaf Lakes contained properties that ranged from 0% canopy cover to 100% cover with the average parcel around the Cloverleaf Lakes having 58% canopy cover. Figure 2 displays the Cloverleaf Lakes and each parcel's respective canopy cover within the riparian zone. Of the 264 parcels, 22% (59 parcels) have a canopy cover which needs suggested major improvements, 23% (60 parcels) have a canopy cover needing suggested minor improvements, 19% (50 parcels) have acceptable canopy coverage, and 36% (95 parcels) have ideal canopy cover. The greater the canopy cover, the more habitat it provides, and the more time it takes for precipitation to hit the ground. This slowdown of precipitation can aid in that

Figure 2. Canopy cover of the Cloverleaf Lakes. The ideal shoreline contains 75-100% canopy cover within the riparian zone, an acceptable shoreline contains 50-75% canopy cover, a shoreline with 25-50% canopy cover is in need of minor improvements, and a shoreline with 0-25% canopy cover is in need of major improvements.

As discussed above, canopy cover is assessed only on trees above 16 feet in height. A concern for many property owners is that the presence of many trees on their property. Large trees can lead to safety concerns during extreme weather events as well as potentially blocking their view of the lake. The number of trees present on a property does not always correlate to a high percentage of canopy cover. A few larger, mature trees may create as much canopy cover as many smaller trees.

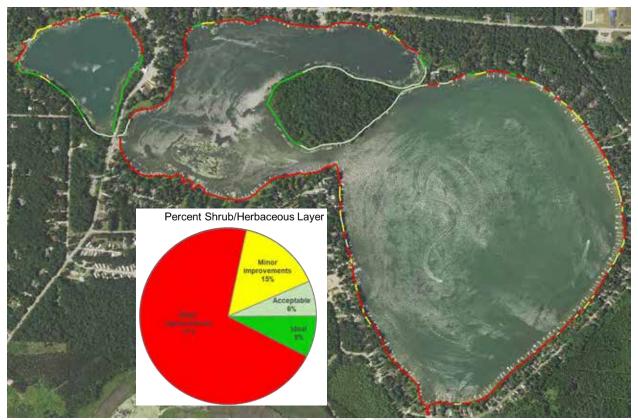
Similar to canopy cover, a strong shrub and/or herbaceous layer can aid in slower run-off on a property. Of the 264 parcels, 203 contain either a shrub or herbaceous layer within the riparian zone, with 122 containing a shrub layer and 192 containing an herbaceous layer. Figure 3 displays the Cloverleaf Lakes and each parcel's respective shrub/herbaceous layer. Of the parcels with a shrub and herbaceous layer, 71% (187 parcels) had no shrub and/or herbaceous layer or a shrub and/or herbaceous layer that would benefit from suggested major improvements, 15% (40 parcels) had a shrub and/or herbaceous layer that

Figure 3. Shrub and herbaceous layer of the Cloverleaf Lakes. The ideal shoreline contains 75-100% shrub and/or herbaceous cover within the riparian zone, an acceptable shoreline contains 50-75% shrub and/or herbaceous cover, a shoreline with 25-50% canopy cover needs minor improvements to the shrub and/or herbaceous layer within the riparian zone, and a shoreline with 0-25% shrub and/or herbaceous cover needs major improvements.

35-foot riparian zone., As a reminder, the easiest way to improve the shrub and herbaceous layer is by adding more plants within the riparian zone. Rain gardens and shoreline restoration projects can be completed to have that same manicured garden look with a nice border. Native plants have the tendency to spread but by adding that border it may help maintain a level of order to the project. An increase in percentage of shrub and/or herbaceous present would be very beneficial to the lake.

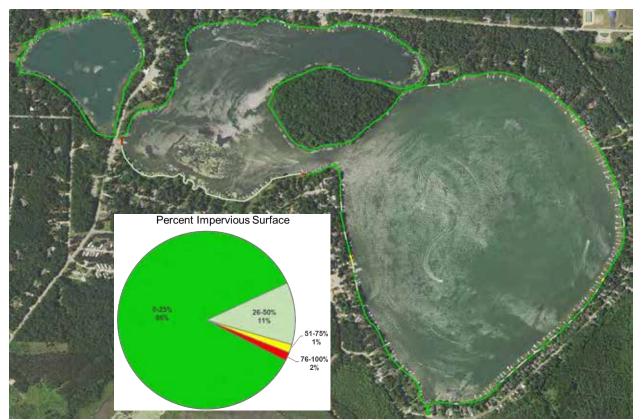
Of the 264 parcels, 209 contained some type of impervious surface within the riparian zone. Figure 4 displays the breakdown of impervious surface around the Cloverleaf Lakes. Of parcels surveyed, 86% (226 parcels) contained 0-25% impervious surface, 11% (30 parcels) contained 26-50% impervious surface, 1% (4

The parcels that contained 75-100% impervious surface were generally boat launches or parts of business that had roads or parking lots near the water.

Figure 4. Impervious surface around the Cloverleaf Lakes. There is no level of impervious surface that is acceptable within the shoreline. The shoreline is broken down into 25% increments to showcase what is present around the Cloverleaf Lakes.

A decrease in impervious surface would be very beneficial for the Cloverleaf Lakes. Even very small amounts of impervious surface can affect fish habitat. Shore spawning and nursery habitat, for many of our fish, are very close to the shoreline. Run-off, impervious surface, and scour causes a decrease in habitat availability for these young fish. Efforts towards removing all impervious surfaces should be made to further protect the shoreline, aquatic habitat, and the water quality.

If the removal of all impervious surface is not possible or undesired, changes to how the run-off leaves the property need to be explored and executed. By pointing down spouts or grading impervious areas toward rain gardens or native plant buffers, improvements can be made to the water running off the impervious surfaces present, while providing habitat.

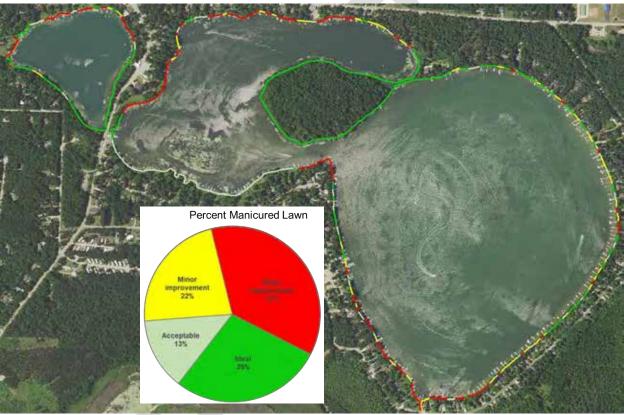
As mentioned above, manicured lawns were one of the more commonly seen things within the riparian zone around the Cloverleaf Lakes. Of the 264 parcels around the Cloverleaf Lakes, 220 contained manicured lawn at varying levels. Of the parcels surveyed, 28% (74 parcels) contained an ideal amount of manicured lawn, 13% (35 parcels) contained an acceptable amount of manicured lawn, 22% (59 parcels) that would benefit from suggested minor improvements, and 37% (96 parcels)

contained manicured lawn that would benefit from suggested major improvements.

Figure 5. Manicured lawns around the Cloverleaf Lakes. The ideal shoreline contains 0-25% manicured lawn within the riparian zone, an acceptable shoreline contains 25-50% manicured lawn, a shoreline with 50-75% manicured lawn needs minor improvements, and a shoreline with 75-100% manicured lawn needs major improvements.

The thing to remember is property owners can have a manicured lawn and native plants to protect the shoreline and add habitat. As discussed in the shrub and herbaceous layer section, more traditional looking gardens can be created with the native plants to give you that balance of lawn and buffer.

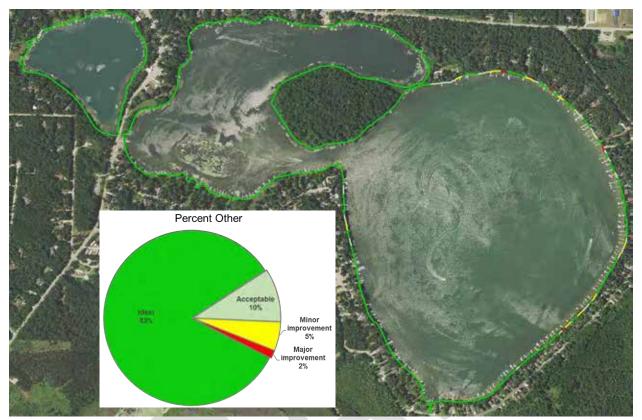
Most of the other ground layer cover that was found around the Cloverleaf Lakes was in the form of duff or

Figure 6. Other types of ground layer cover around the Cloverleaf Lakes. The ideal shoreline contains 0-25% other types of ground layer within the riparian zone, an acceptable shoreline contains 25-50% other types of ground layer, a shoreline with 50-75% other types of ground layer needs minor improvements, and a shoreline with 75-100% other types of ground layer needs major improvements.

sandy beaches. One way to decrease the amount of other ground cover types around the Cloverleaf Lakes would to transform the beaches into native plantings or even maintained lawns. The most important thing to do is to keep the soil and sand on the landscape. This can be accomplished by more and better root structures. While the ideal situation would be to completely remove beaches and other ground cover types and replace them with native plants, we understand that is unrealistic. Even changing a small portion of beach, or other area, to native plantings can have great benefits.

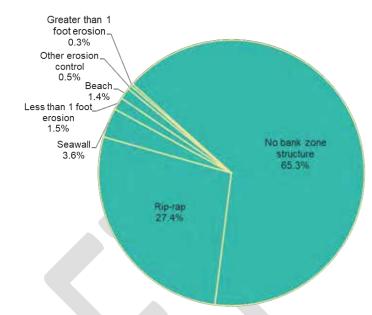
During the Cloverleaf Lakes shoreline survey, it was found that approximately 65% of the shoreline (3.4 miles) were unaltered or lacked erosion, 27% of the shoreline (1.4 miles) contained rip-rap, 4% (994 feet) contained seawall, 1.5% (421 feet) contained less than one-foot erosion, 1.4% (381 feet) contained beach, less than 1% (135 feet) contained other erosion control structures, and less than 1% (79 feet) contained greater than 1-foot erosion. Figure 9 displays the breakdown of the bank zone around the Cloverleaf Lake.

Figure 9. Bank zone structures and concerns around the Cloverleaf Lakes.

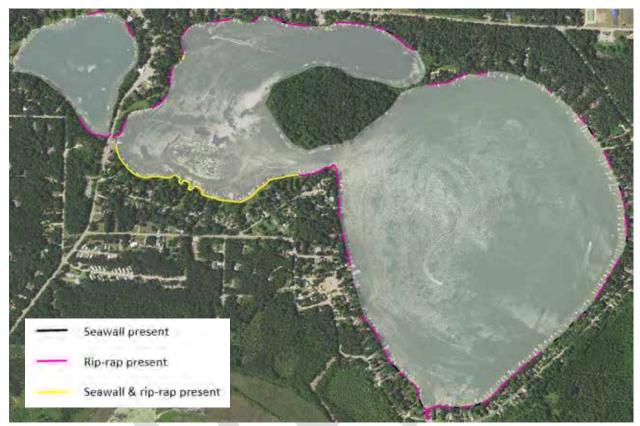
Research has found that wind and wave action against seawalls can cause a lack of submergent and emergent plants to be present in front of seawalls. This scouring of the lake bottom can have negative effects for lake-life (Figure 10). Other concerns with seawalls are: loss of fish spawning and nursery habitat, preventing amphibians and reptiles from getting into and out of the lake, prevention of future recruitment of fisheries habitat.

Figure 11. Seawalls and rip-rap present within the bank zone of the Cloverleaf Lakes.

In a perfect world, seawalls would be pulled out and replaced with practices like coir biologs and native plants but this is not always realistic for property owners. Adding native plants near the border of seawalls can help alleviate the run-off concerns that occur with the presence of seawalls.

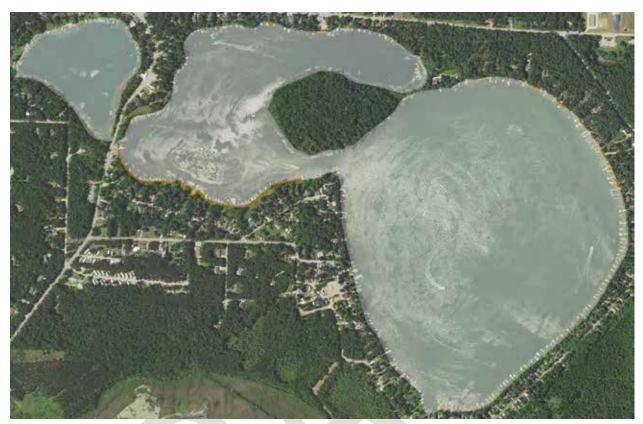
The presence of beaches around the Cloverleaf Lakes was a concern brought to Connecting Our Waters as we were preparing for the presentation given at the Cloverleaf Lakes Protective Association's annual meeting.

Figure 12. Beaches present around the Cloverleaf Lakes.

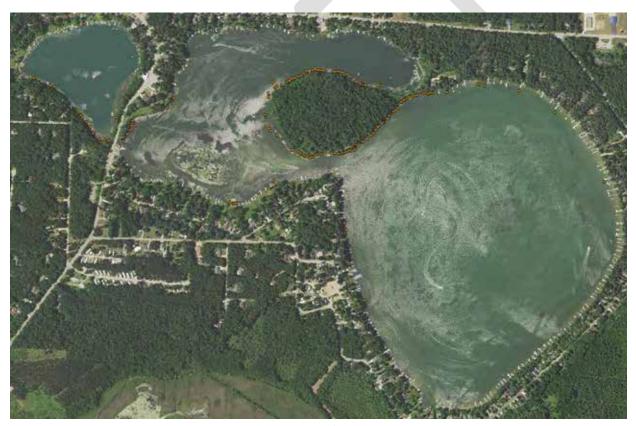
The coarse woody habitat survey was completed on July 30th. One hundred and sixty-five pieces of coarse woody habitat were found around the lake. The majority of the habitat found were of higher quality, meaning they had some branching, crossed the high water mark, and were in the water.

Figure 13. Coarse woody habitat around the Cloverleaf Lakes.

Coarse woody habitat provides great fish habitat. Addition of tree drops, anywhere on the lake, will be beneficial for the lake. The Healthy Lakes grant program offers cost sharing for adding fish sticks (tree drops) to the lake. The Healthy Lakes grant Action Plan can be found in Appendix B.
