Cloverleaf Lakes, Shawano County
Shoreline Assessment 2020

2020 Cloverleaf Lakes Survey

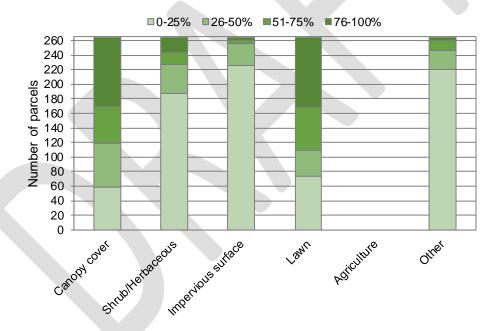
Figure 1. Percent breakdown of parcel canopy cover and ground cover. Each column will equal 264 for the 264 parcels surveyed.

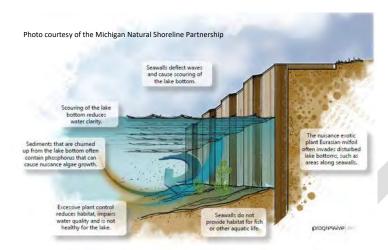
Figure 10. Illustration of wave action against a seawall. Courtesy of Michigan Natural Shoreline Partnership

Research has found that wind and wave action against seawalls can cause a lack of submergent and emergent plants to be present in front of seawalls. This scouring of the lake bottom can have negative effects for lake-life (Figure 10). Other concerns with seawalls are: loss of fish spawning and nursery habitat, preventing amphibians and reptiles from getting into and out of the lake, prevention of future recruitment of fisheries habitat.

In a perfect world, seawalls would be pulled out and replaced with practices like coir biologs and native plants but this is not always realistic for property owners. Adding native plants near the border of seawalls can help alleviate the run-off concerns that occur with the presence of seawalls.
